Poultry Slaughterhouse Design - Materials & Safety : Lessons From Slaughterhouse Fires

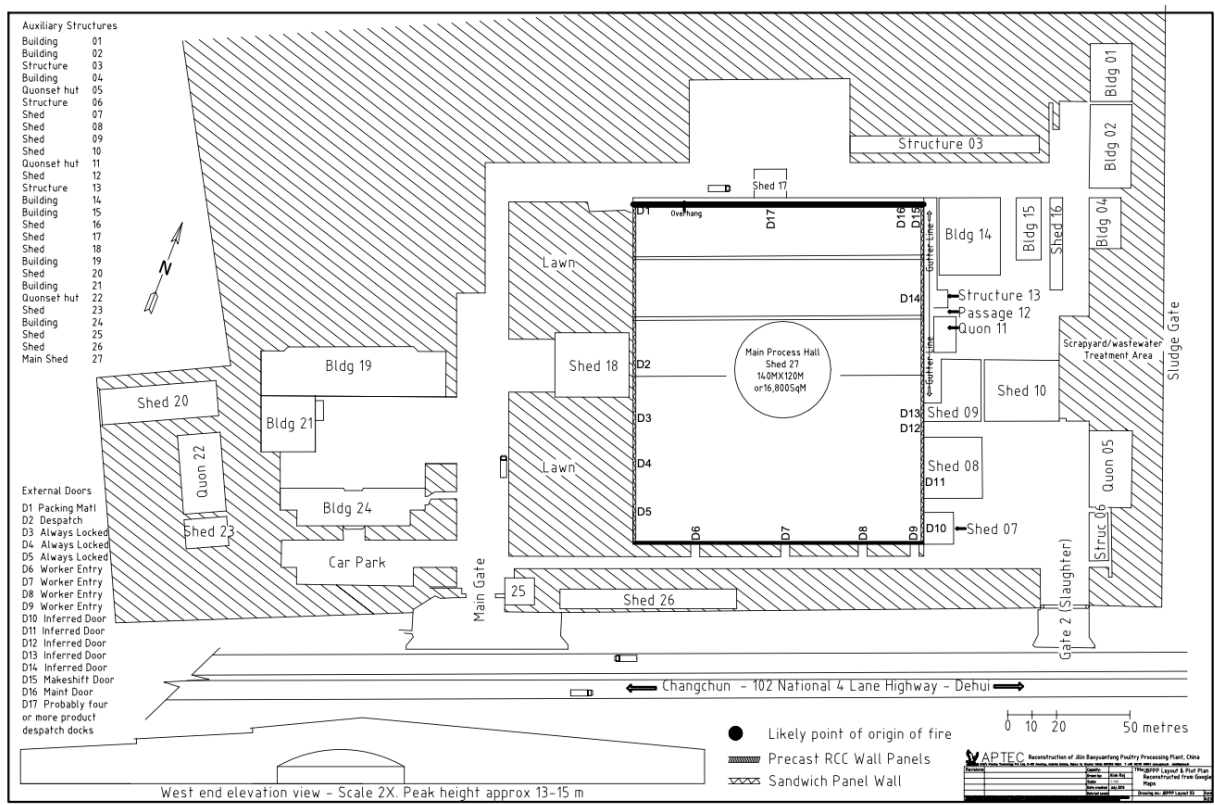
Figure 7 Reconstruction Of The Jilin Baoyuanfeng Poultry Processing Plant Plot Plan (traced from an import of a 100M Google map into Autocad). All building, door and feature numbers mentioned in this report follow those given in this drawing.

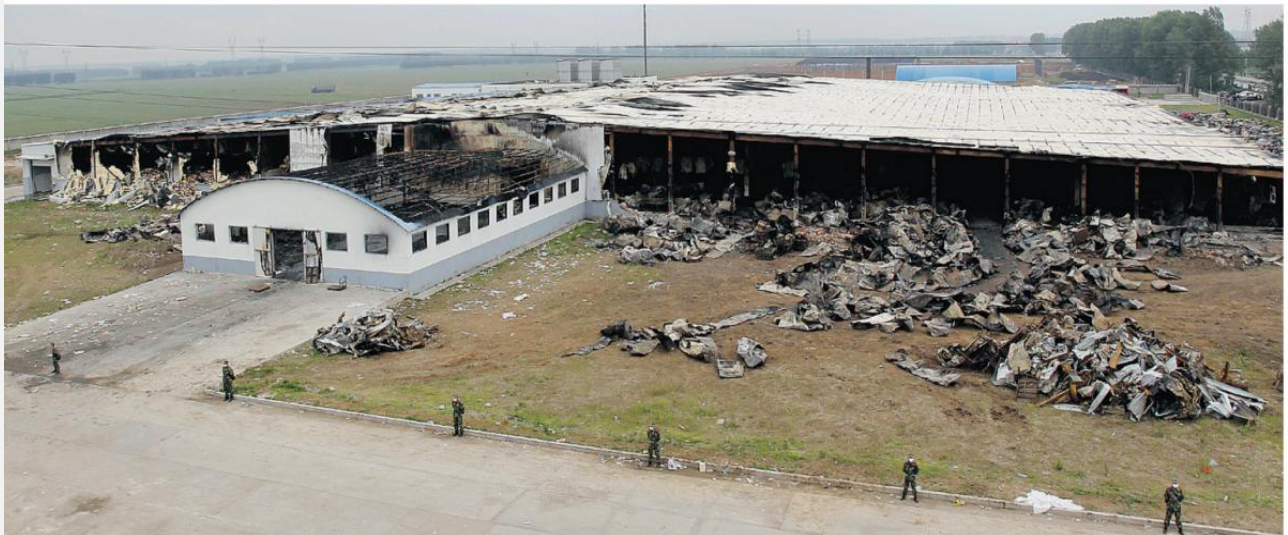
Figure 8 Aerial view of the plant after the fire had been controlled and guards were posted on its perimeter. This picture shows that the north half of the building was completely gutted, though the south half, just beyond the central ridge, remained substantially intact. Except for shed 18 in the centre and the secondary packing material receipt door (D1) on the extreme left, there were three other doors (D3, D4, D5) along the west wall, on the south of shed 18, which were destroyed as a result of rescue activities. These three doors were locked – the lawn giving ample testimony to this fact by bearing no signs of footpaths, although light traffic along the plinth protection might still have been possible. Going from left to right in the background of this picture (or along the east end), are three buildings (Buildings 01, 02 and 04), an intact smokestack arising from the vicinity of buildings 14 and 15, a truncated smokestack arising from the vicinity of sheds 08 and 09, the gable-end view of shed 08, the blue-domed Quonset hut 5 (housing the effluent treatment plant) and the gate for entry of trucks carrying live chicken. The truncated smokestack in the vicinity of sheds 09 and 08 was complete in the early stages of the fire (figure 13) and was probably deliberately cut off to allow freedom of movement to the fire engine boom.

Sandwich panel walls (on the west and north). Look at figure 8. In the foreground you can see piles of sandwich panel steel linings which have been pulled off the western wall. Because these linings are only approximately 0.5mm thick, and because they have suffered fire damage, they are thoroughly crumpled. Why would an architect specify this material for the external wall? Probably because most of it was meant to retain the cold conditions in the frozen store. We have therefore drawn a rather large frozen store at this end in figure 10.

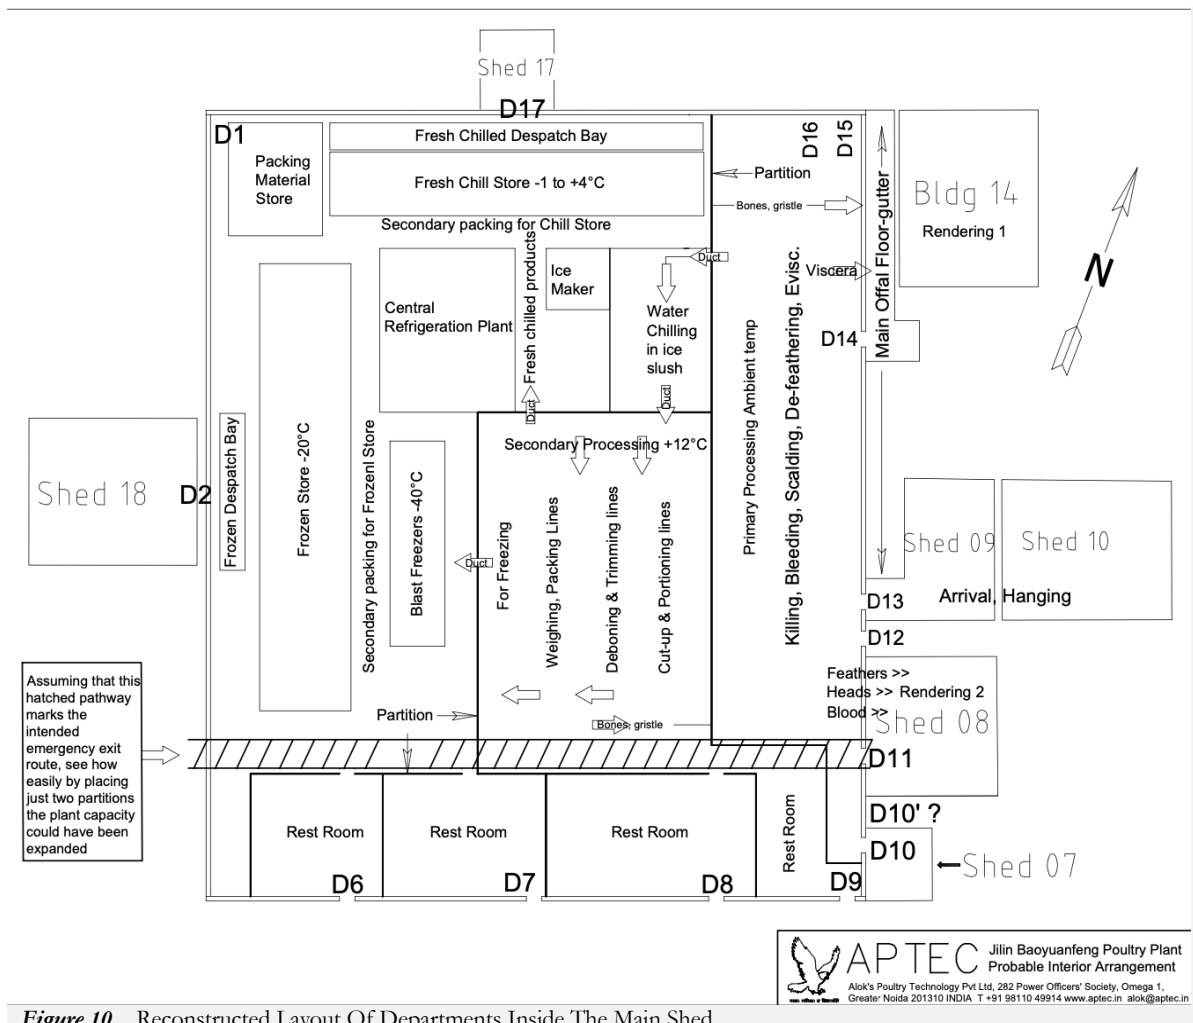
Figure 10 Reconstructed Layout Of Departments Inside The Main Shed

The owner of this plant appears excessively keen to minimise his investment, else he would not have opted for ice slush chilling (figure 30, where it is called pre-cooling pond). It is very rare to find an ice slush water tank in a 21st Century plant. Modern plants almost as a rule deploy a bank of screw chillers which chill carcasses from the initial 40°C down to under 7°C in a matter of 35 to 40 minutes. An ice slush water tank, on the other hand, takes

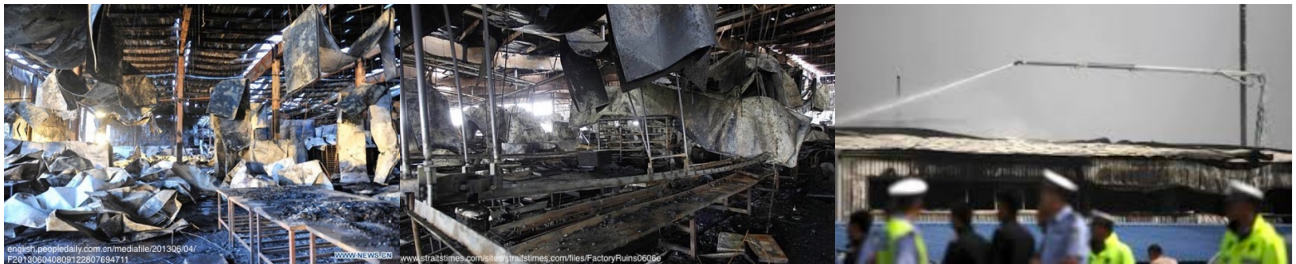
Figures 11, 12, 13 Left picture (11) shows trimming tables of a typical height of 800mm, arranged end to end. Middle picture (12) shows a J shackle line with the remains of a belt conveyor. Right picture (13) shows the presence of a second smokestack rising from somewhere in the vicinity of shed 08. The other smokestack rising from the vicinity of building 14 is also visible here.

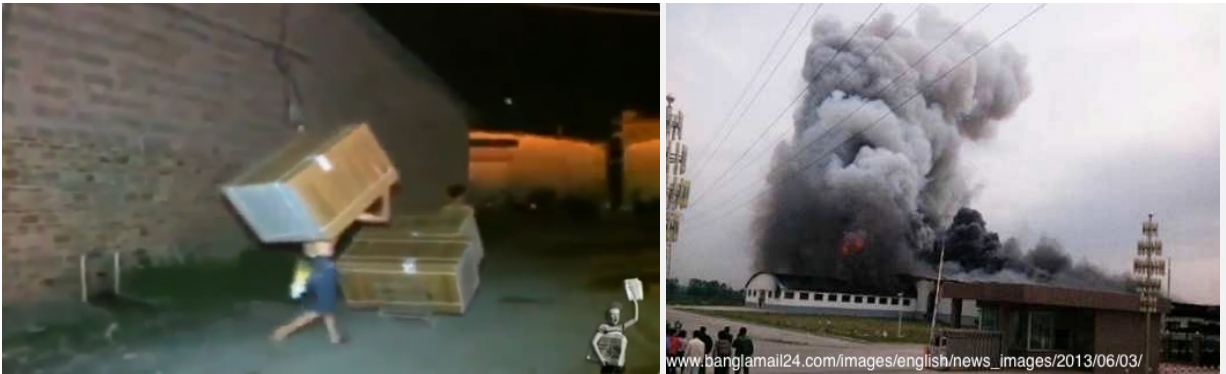
Figures 14, 15 Figure 14 is a frame grab from a video shot in the evening of June 3, perhaps 13 or 14 hours after the fire started²². The orange glow in the background is not the setting sun, but a glow from flames over shed 17 or 18. While the main shed area immediately behind D02-Shed-18 was ablaze even 13-14 hours after the start of the fire, workers are seen rescuing packed chicken from what looks like somewhere in the middle of the north end.

If the origin of the fire was close to the central refrigeration plant where it has been shown in figure 31, why is some smoke issuing from the east end in figure 15? Note that this is a very early stage of the fire – the thick smoke cloud has not yet reached the upper border of the picture. In a poultry processing plant it is customary to have exhaust ducting drawing stale air from the clean areas towards the dirty areas and out. The dirty area in this case is in the east and clean areas are to the west of it, separated by a wall. There is a hot smoke column right over the west end and smoke from the east end termination of the ducting is seen hugging the roof to join the updraft created by the main smoke column.

North of the central ridge the shed has two longitudinally running sets of roof monitors, possibly provided with glazing and vents (figure 33). That they do have vents is evident from the large amount of thick black smoke apparently issuing out of them in Figure 15.

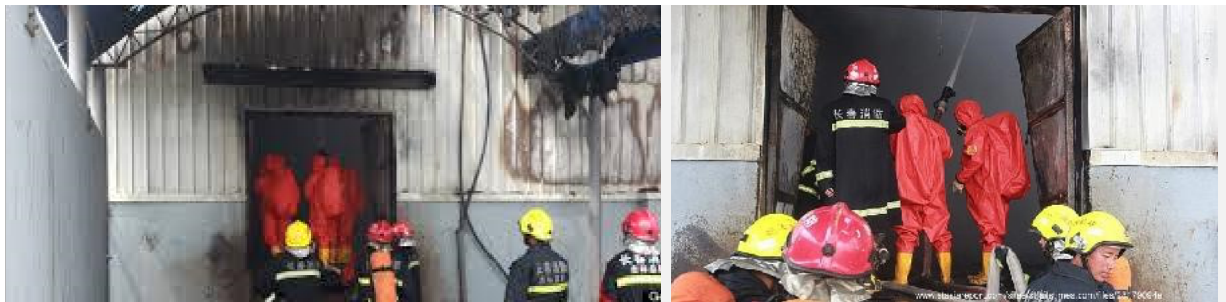
Figures 16, 17 Note that this end has a high plinth and therefore these pictures have been shot at the east side. Figure 16 is the external door of shed 07. Note the eaves end truss of the main shed towards its left. In figure 17 you see a close-up view of D16. Another view of it appears in figure 25.

The plinth of the main shed is substantially higher than ground level at the east and north-east ends and has sets of steps leading in (figures 16, 17, 24 & 25). Since the bird arrival end should have a plinth of approximately 1200mm above ground level, one can say that the natural slope has been used advantageously in the design of this plant. Therefore we may conclude that the live bird receipt is done in the east. This is further corroborated to by the existence of the live bird gate in the east end of the compound (as distinct from the product despatch and workers' entry gate at the west end) and random dumping of some of the effluent sludge just outside a gap in the eastern compound wall (figure 33). There is a breach in the compound wall to facilitate the dumping of sludge in the adjoining field. This breach has been named 'sludge gate' in figure 7.

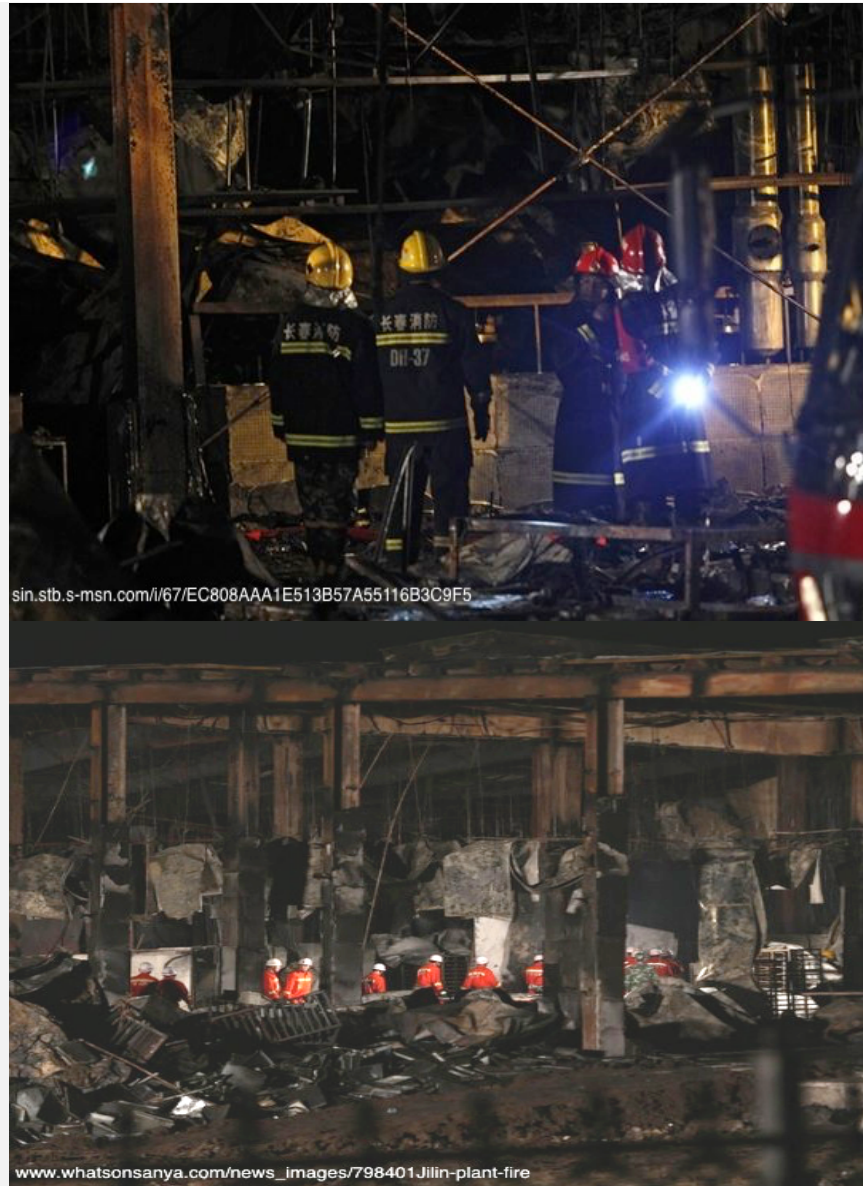
Figures 18, 19. The first picture of the interior of the building, shows thermally insulated refrigeration piping and rescue workers are cutting away something. Guy wire stays suggest this may not be a normally accessible section or work area. In the second picture rescue workers are somewhere close to the high ridge, which, judging from their height, appears to be around 13-15 metres. Note the delaminated false (drop) ceiling sandwich panels still hanging at approximately 6 metres height.

Figure 18 shows large aluminium sheet clad vessels and pipelines situated inside the building. Also, there are guy wires strung diagonally and appear to be holding some large structures upright. The presence of diagonally placed guy wires precludes the possibility of this area being in general use for poultry processing. We believe this is the central refrigeration plant.

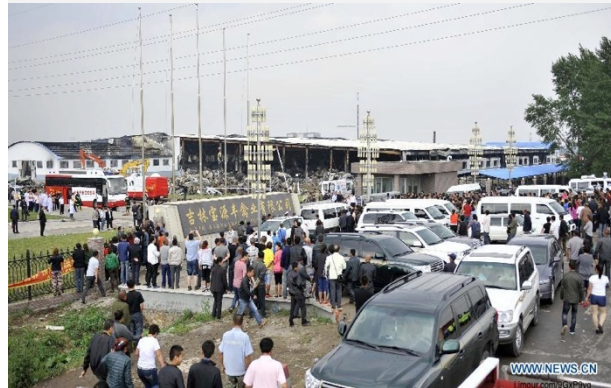
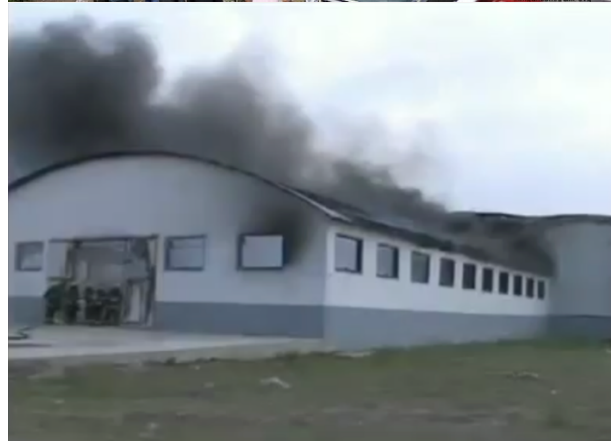
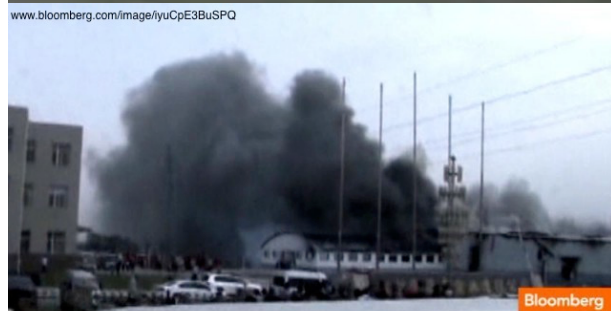
Figures 20, 21, 22 Top picture was taken from the main gate before the fire. It shows buntings and a motorcycle shed on the south end. The middle picture is from a BBC video²⁴. It and the next two were shot at very early stages of the fire. The smoke is issuing from the west (despatch shed 18) end of the building in figure 20 where it appears to have originated²⁵

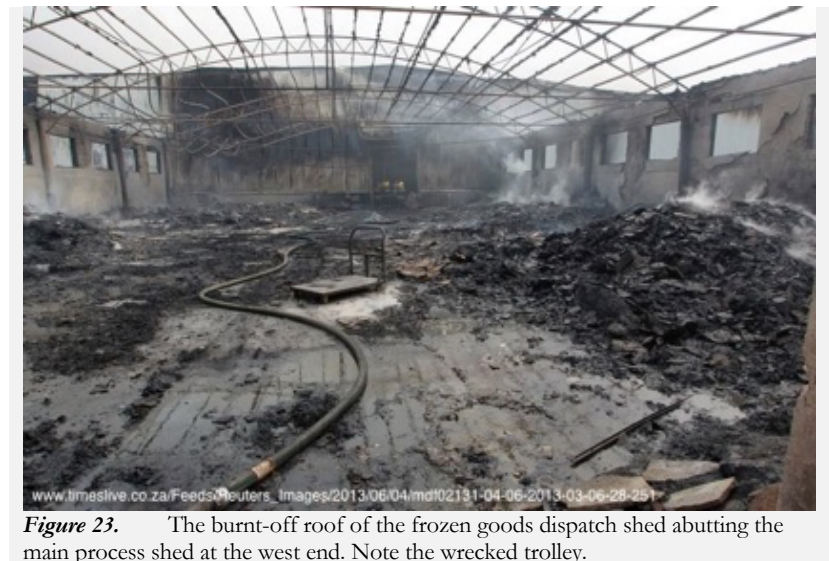
Figure 23. The burnt-off roof of the frozen goods dispatch shed abutting the main process shed at the west end. Note the wrecked trolley.

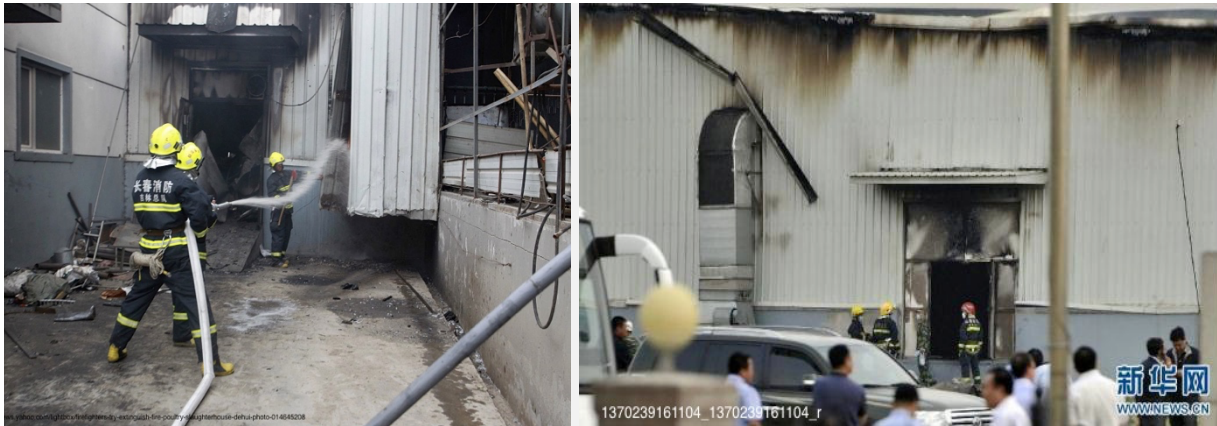
Figures 24, 25 Picture 24 (left) shows two firefighters standing in one of the lanes formed by two abutting sheds and structures to the east end of the main process building. This has been identified as a possible door between sheds 07 and 08 sheds. Note that shed 07 is intact while shed 08, which probably housed part of the rendering 2-boiler complex or the feather store, is gutted. The picture on the right (25) taken at the north side, shows some signs of fire and a collapsed roof-gutter. These form two possible emergency exits. The odd shaped door on the left was probably added as an afterthought – the height, shape and absence of protection against rain at this doorway suggesting that it opens not into the process area, but into an internally located maintenance area.²⁷

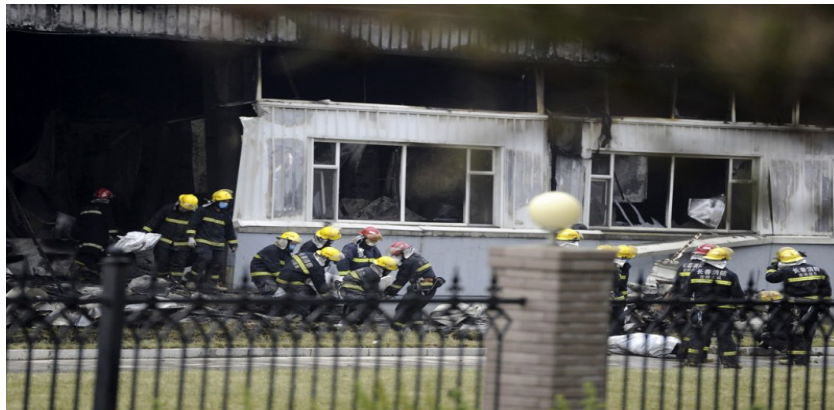
Figure 26. This picture gives a good idea of the roof height at the eaves on the south end – some 7-8 metres. It also gives a good view of the prefab construction with fixed windows. Notice the vertical smear line left by escaping smoke. This line marks the joint between two adjacent prefab panels. The north wall comprises prefab panels alternating with sandwich panels, but the south end has only prefab sections.

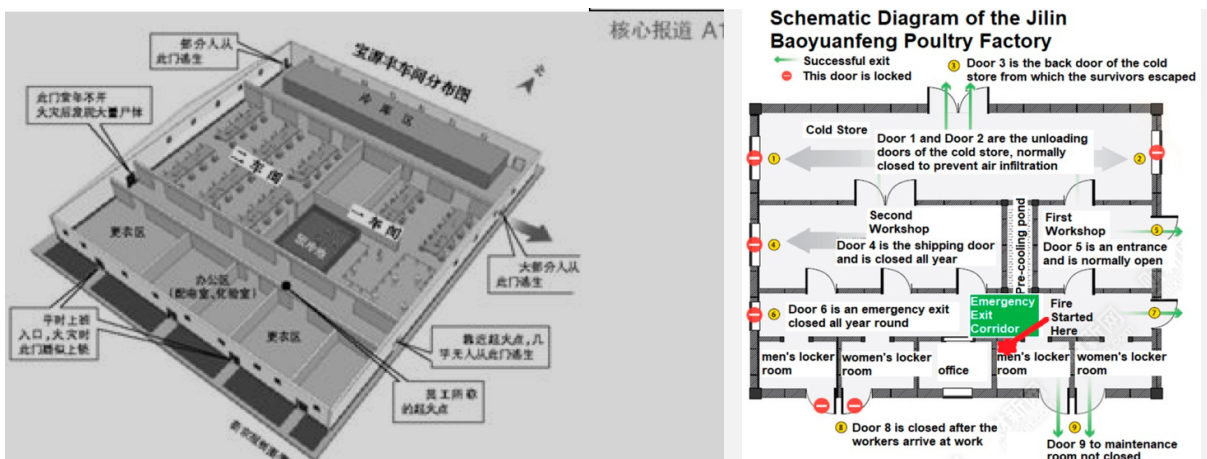
Figure 30, 31 Aptec is in possession of two layout diagrams of the internal arrangements of the main shed. The one on the left³¹ showed up in 2013 around the time the original article had already been written. Not knowing the language, all we could say was that the arrangements bore some similarity with our own interpretation which has now been drawn and presented in figure 10. The picture on the right (figure 31) was sent to us by Dr Pearson in late 2022, bearing only Chinese text first and later, bearing a rough translation as shown. It was published by Caixin, a Chinese news agency.

We can see that there are many similarities (and some significant differences) between the findings of Aptec presented in this article and those in Caixin’s sketch. These are explained in table 32.

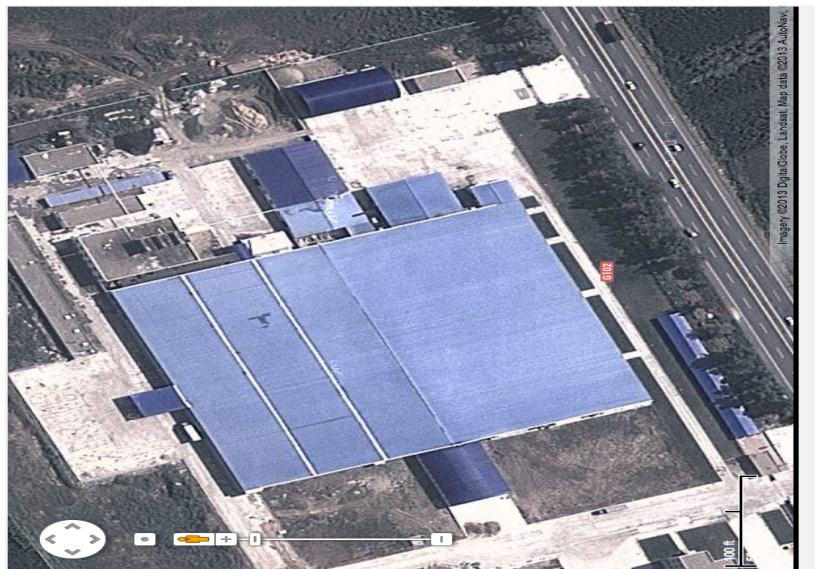
Figure 33 Google Map³² chosen for reconstruction of the facility using Autocad

There are no roof-mounted air extractors on the south half of the main shed roof in figure 33. The north half, having sustained more burn damage, clearly had two ridges to provide extraction of stale air from work spaces and allow entry of north-light into the attic. If one assumes that movement of air out of the building is not natural but directed entirely on forced basis (as it might well be, considering the massive size of the building), then one must either ascertain or eliminate the possibility of wells (or shafts open to the sky) within the building. The aerial photograph in figure 8 shows none, nor does the Google map illustration in figure 33. Air intakes, if they existed, can therefore be inferred to have been placed along the eaves. But as the majority of eaves have been dismantled, we can not be certain of this.

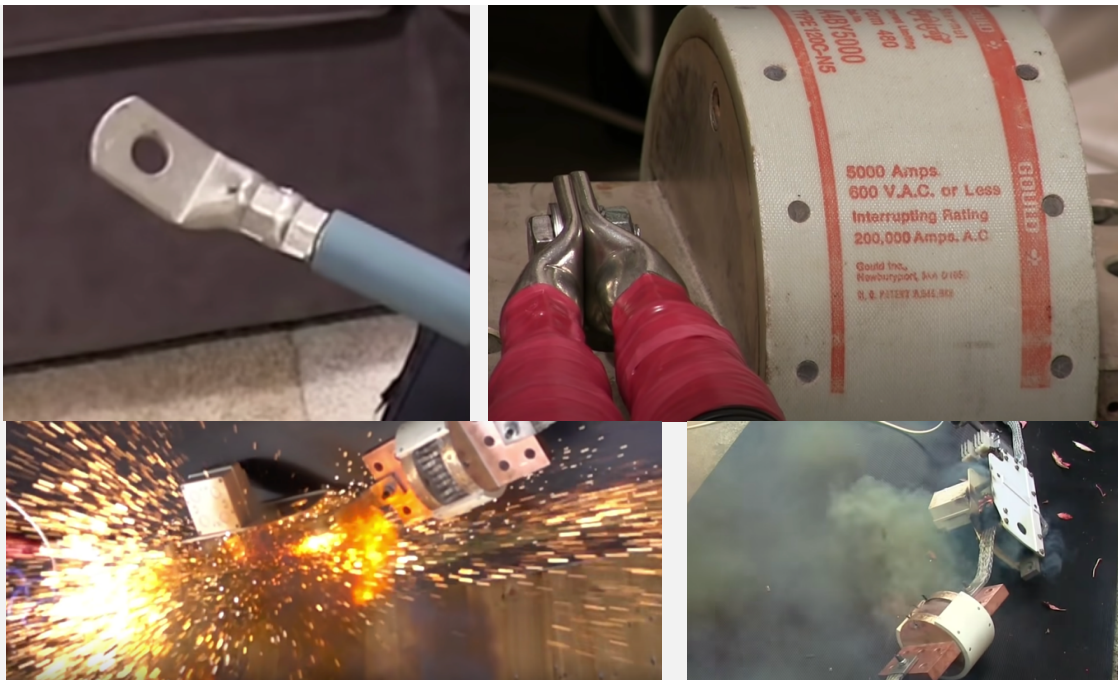
Figure 37, 38, 39, 40 Top row shows cable terminations properly crimped to ensure good conduction. When terminations are improper or when they and the cables are required to carry much higher current than they are designed for, they heat up, oxidize, which in turn further worsens the heating effect and then they reach a temperature where the metal melts or vapourizes with the effect shown in figure 39. Here some metal has vapourized or exploded and a lot of the remainder has melted into glowing sparks. In figure 40 a 5000 ampere HRC fuse has ruptured with a similar overload, but resulted in a much weaker explosion. Note the grey vapour around the fuse. It is vapourized metal. **When you watch the video³⁶ you can experience the true magnitude of the explosions** accompanying each event.

We additionally hypothesize that this control or distribution panel was located inside the building. Since the plant had expanded very rapidly, the conductors were being made to carry much more current than they were initially designed for. The electrical cables and bus bars were constantly running hot. Both of these are made of aluminium. When aluminium runs hot its surface oxide layer builds up and makes increasingly poorer electrical contact. This sets in place a positive feedback loop and sooner or later a large portion of the conductors at the termination points heat to the point of melting and then the molten metal evaporates into a metallic cloud in the form of an explosion. One large explosion may physically disturb adjacent terminations sufficiently to cause sympathetic explosions in other circuits – but once this is stretching things a bit! And you need to form your own opinion whether the 5 kiloampere explosion is loud enough to have been heard outside the shed.
