What Happened at Jilin Baoyuanfeng on June 3, 2013

This report is in two parts – the first addressed to design professionals; the second to the public at large
Report dated July 25, 2013, Rev 1 dated August 10, 2013

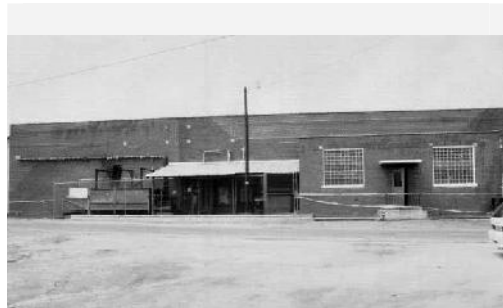
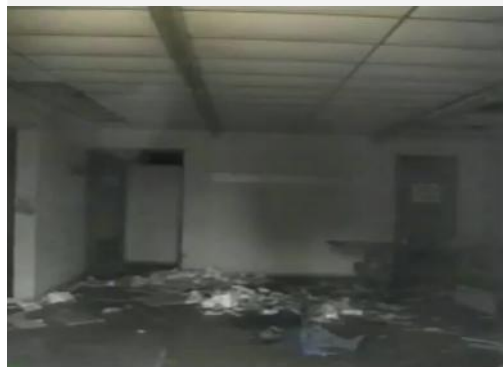
Figures 1, 2. Imperial Foods Plant at Hamlet before the fire; Drop ceiling is barely over 3 metres high. *Source: World History Project, video- ibid*

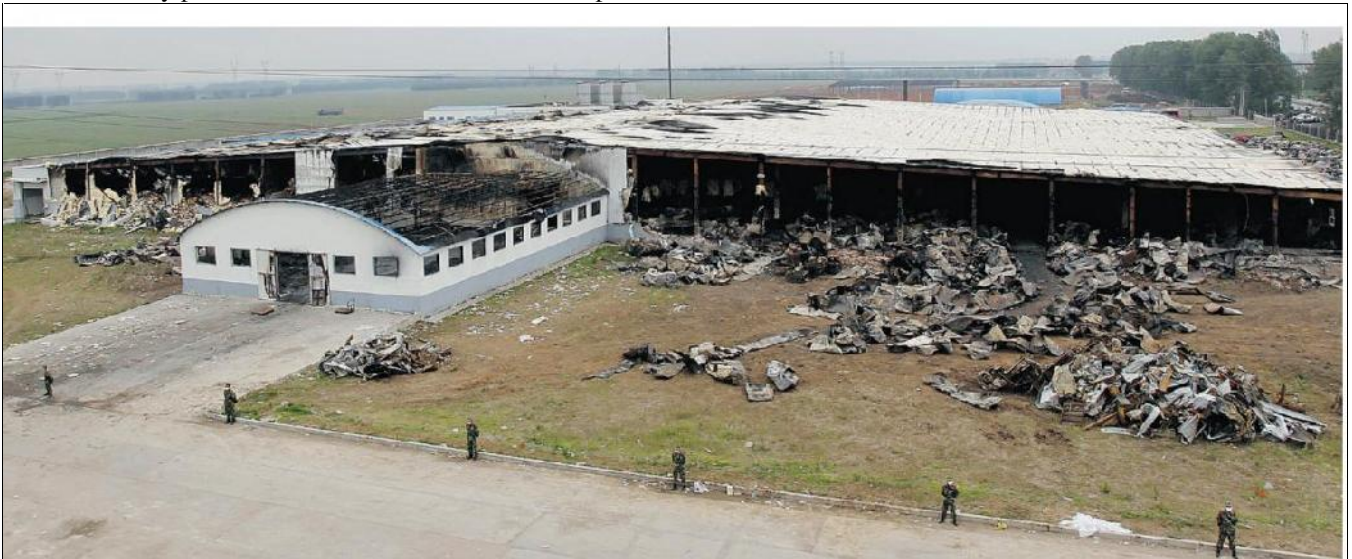
Refer to Figure 5. The hut in the forefront (West end) probably served as one of the dispatch sheds. Under the first window to the right of its solitary door, one can see a wheeled trolley. Figures 5 and 17 show this and another wheeled trolley, which were probably used to ship out finished goods cartons into dispatch trucks. That the floor level of this dispatch bay is at road height probably mandated loading with the help of a fork lift. Not visible in this picture, there is another dispatch door – on the North side.

Figure 5 - Aerial View of the plant after the fire had been controlled and guards were posted on its perimeter. This picture shows that the North half of the building was completely gutted, though the South half, except for the central ridge, remained substantially intact. Except for the entrance hut in the centre, there was only one other door (on the right) which has been obscured in this picture as a result of rescue activities, and the entire front of the building was closed to traffic – the lawn giving ample testimony to this by bearing no signs of footpaths. (Light traffic was however possible over the plinth protection skirting the building). In the back, representing the East end, are the canteen - a multi-storey building, the boiler and chimney and the blue dome like structure is one of two Quonset huts⁷ in the complex.

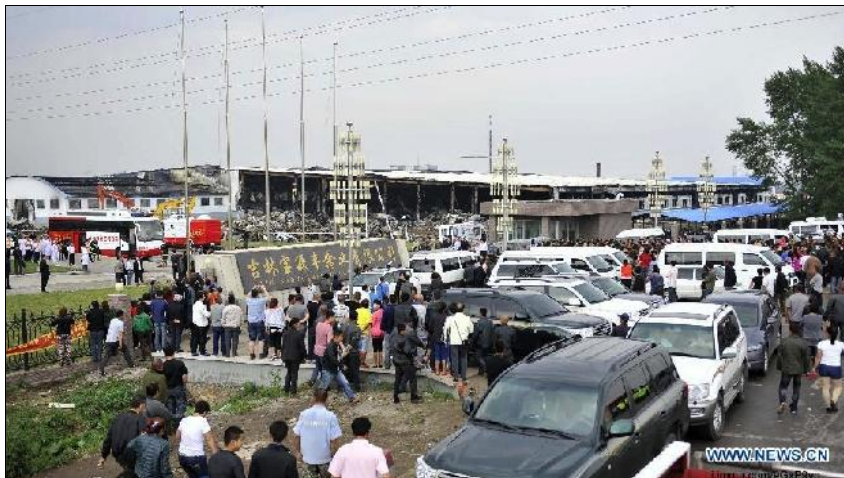
Figure 6. This view, taken from the main gate shows the bunting, motorcycle shed, boiler chimney and canteen building on the far East end

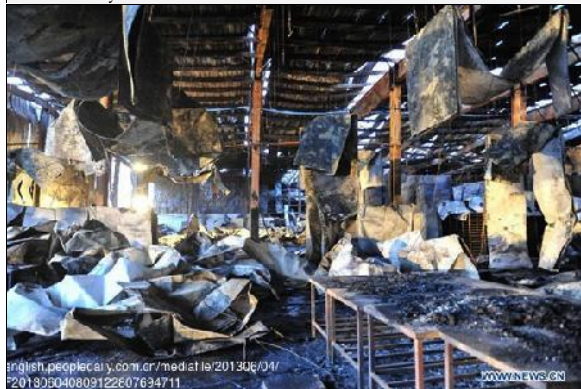
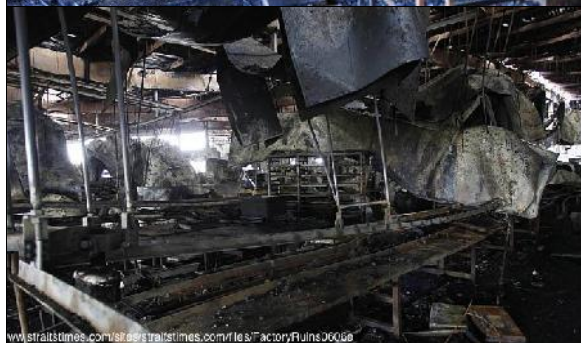
Figures 9, 10. Estimating shift capacity and probable number of workers present in the plant at the time of the fire. Top picture shows a J Shackle Stork line or its clone with the remains of a belt conveyor. Bottom picture shows trimming tables of typical height 800mm, arranged end to end. False (drop) ceiling in the bottom picture is at approximately 5-6 metres above FFL.

Figure 10 shows the mangled remains of a semi-automatic cut-up line called the “Japanese Cut-up Line” or the “J-Shackle Line” in the industry. A central belt conveyor stands immediately below an overhead conveyor line (“T” track - remains and ceiling supports for which are visible in the foreground) Arranged along both sides of the belt conveyor are rows of work platforms called Lady-Lane Trim Tops. However, these J Shackle Lines are not enough for the extensive product finishing carried out at this plant as Figure 9 shows lines of manual trimming and finishing tables arranged according to workflow.

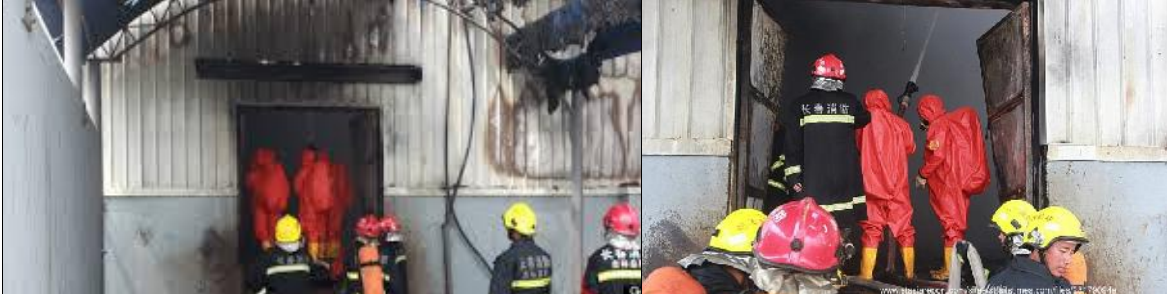
Figure 11, 12. The East side of the building (the rear in Figure 5), serves for arrival of live birds. In the above pictures you can see rescue attempts being made from one such bays after the firemen have knocked open the door from outside. The roof of the bay shelter (Figure 11) is gone, probably blown off and the heat signature on the sheet metal wall of Figure 12 shows that the insulation was on fire from within. Notice that this bay has a big plinth.

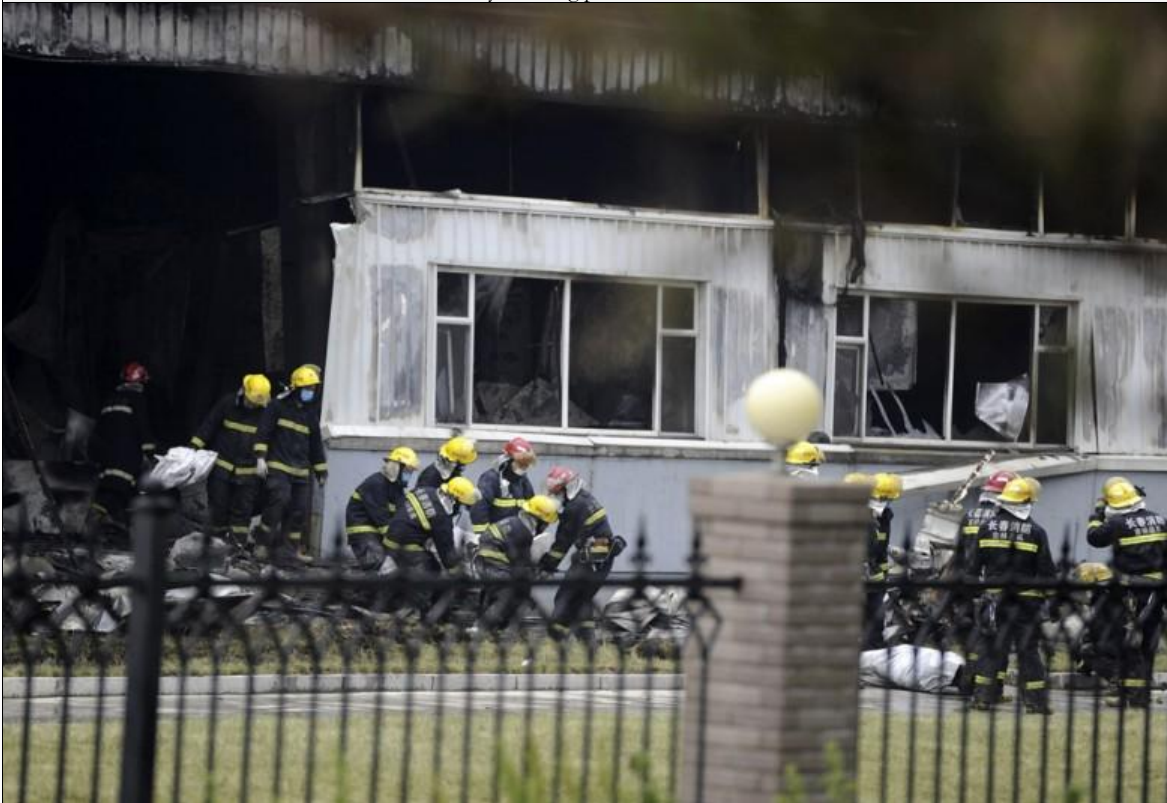
Figure 13. This picture gives a good idea of the roof height at the South end –some 6-7 metres. It also gives a good view of the prefab construction with fixed windows.

Figure 13 shows some design details. Prefabricated RCC exterior walls with doors and windows, sandwich panels above that, joining it to the roof eaves. The most common cores in sandwich panel construction are

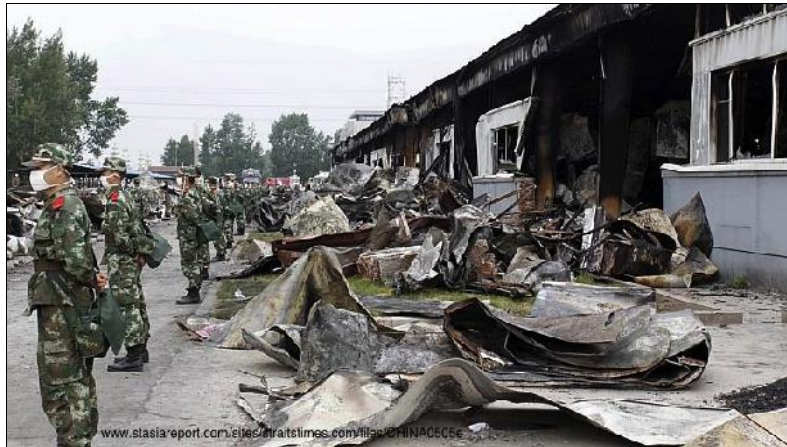
Figure 14. Taken from the East end, close to gate 2, this shows construction details. The sandwich panels in this and several other pictures have completely delaminated. Behind the main shed you can get a glimpse of the admin building and to the extreme left the row of buntings at the main gate.

The commonest criticisms of EPS panels in fire relate to the delaminating of the outer skins exposing the core and its failure to stay in place instead of collapsing and the fire spreading within the panel. Electric cables, which are placed over the false (drop) ceiling, come down with the collapsing panels. This is probably what happened at JBPPP, leading to power outage immediately after the fireball raged through the building. If there was an emergency lighting cabling, that also failed probably because its cabling also ran atop the panels.

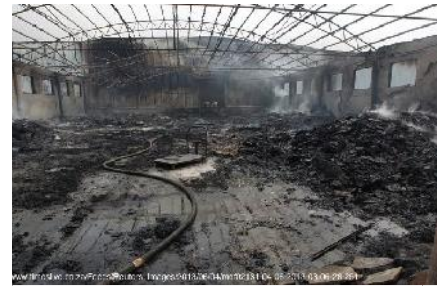
Figure 17: The burnt off roof of the finished goods dispatch shed abutting the main process shed at the West end. Note the wheeled trolley

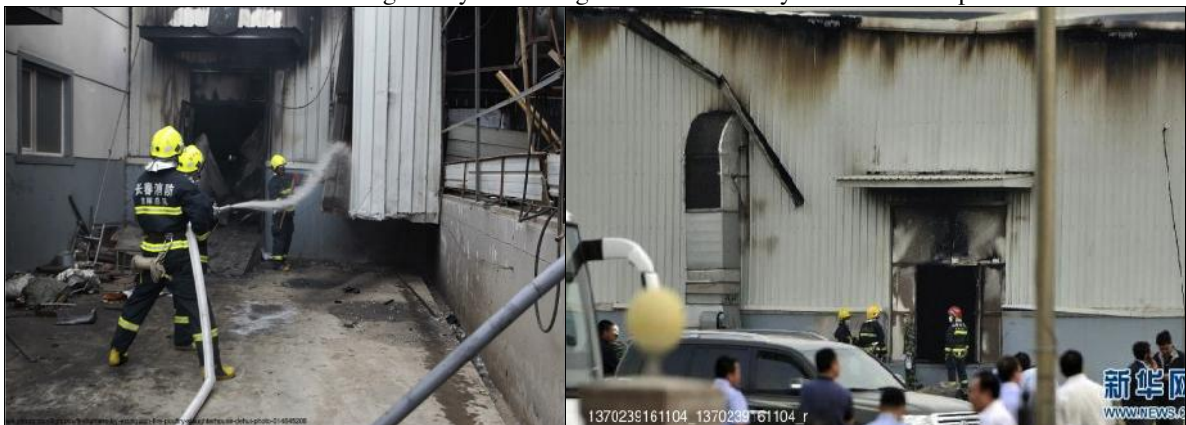
How many emergency exits are there? One door on the West side, not visible in Figure 5 (read also the text below Figure 5), three on the East side (Figures 18 and 19), maybe some on the North side for which we have no evidence, material dispatch and packing material receipt doors (3 nos) and of course all four doors on the South, provided they remained open. Exit is also possible through the dispatch bays and live bird arrival end and possible utility line service gates. There is also the likelihood that the normal exit to the canteen structure could serve as a getaway. But this gate would certainly be locked except at meal times.

Figures 18, 19 The first picture shows firefighters located in one of the bays formed by the several abutting sheds and structures to the East end of the main process area. The other picture, taken at the West end, before the entire wall was torn down as part of rescue efforts (Figure 5) shows some signs of fire and - a collapsed roof-gutter. This forms two possible emergency exits, one of them added as an afterthought – the height, shape and absence of protection against rain at this doorway suggesting that it opens not into the process area, but into an internally located utility area..

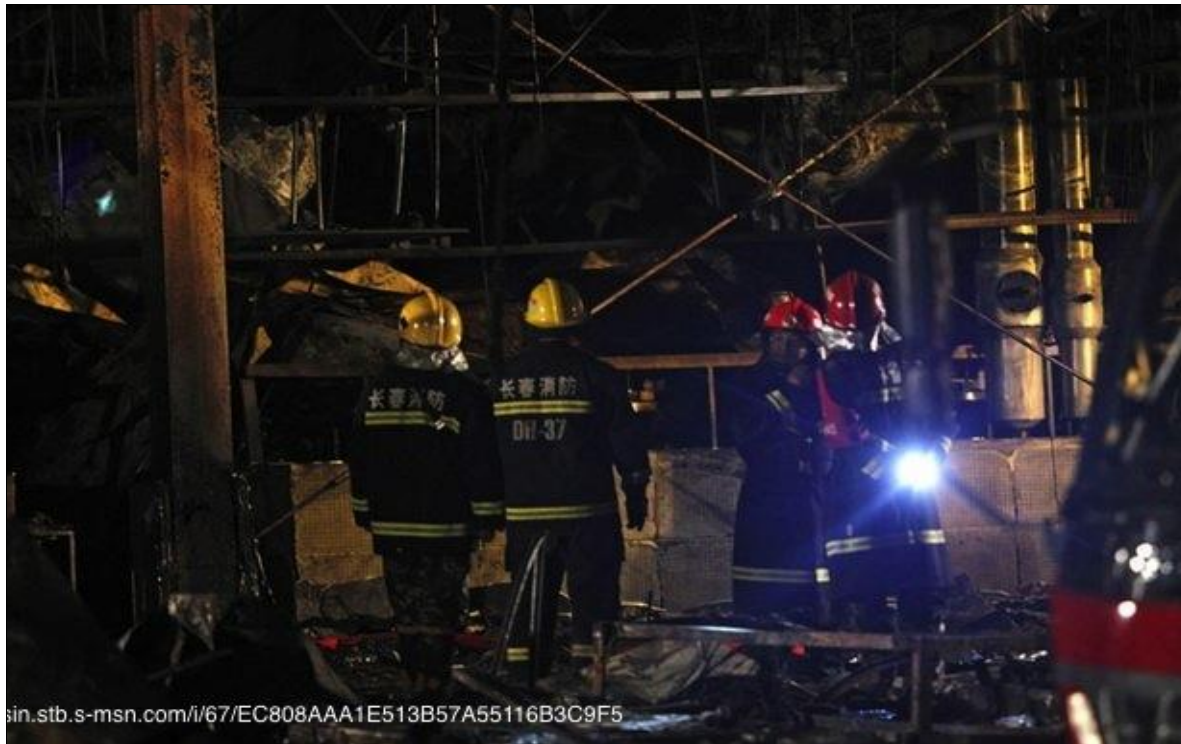
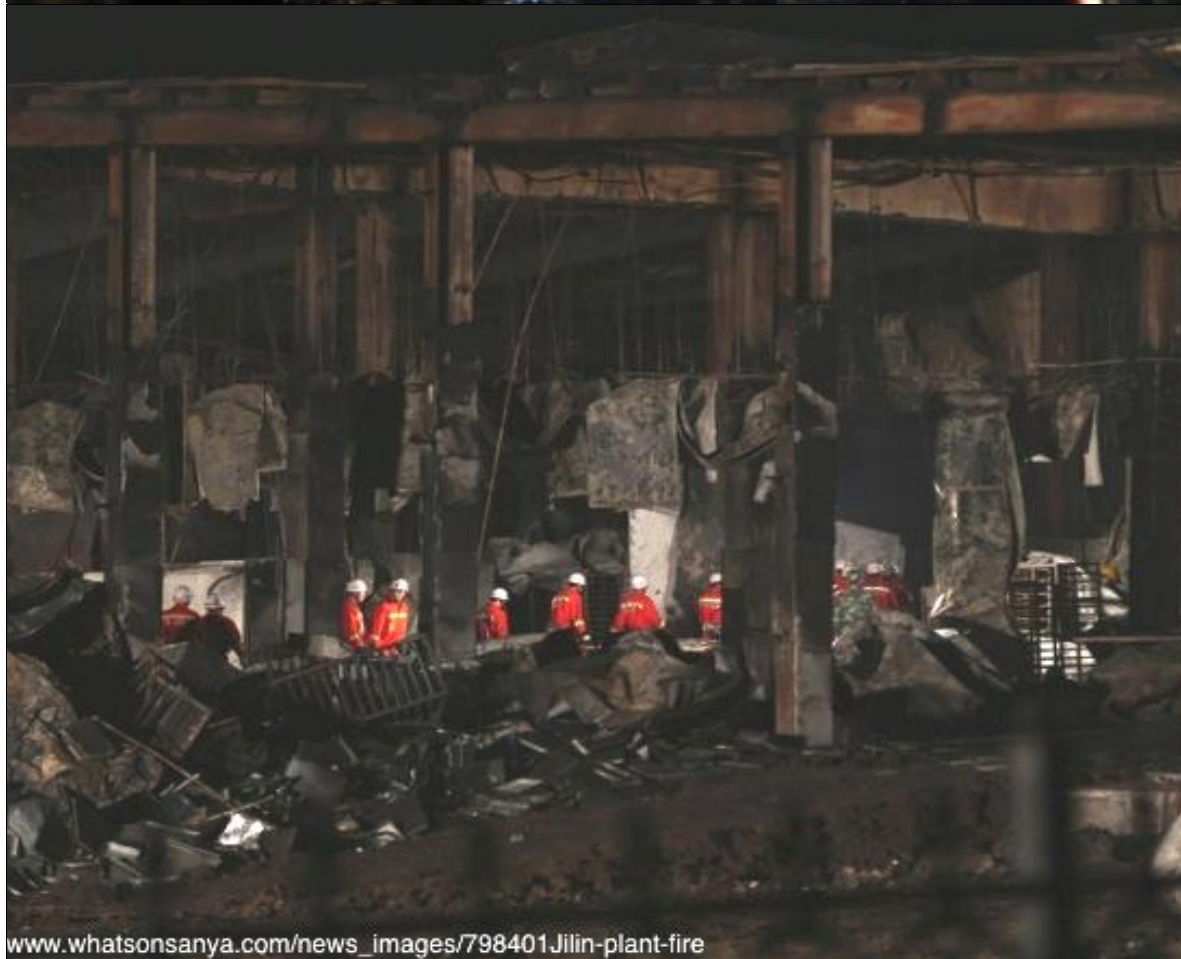
The main process building has a plinth of approximately 17000 square metres (140m x 120m). It has a peak height of 14-15 metres (Figure 21) and an average height at the North and South ends, of between 7 and 8 metres. Assuming that the inside floor was level throughout, the building houses some 185,000 cubic metres of workspace. Above this general floor space would be a false (drop) ceiling at approximately 6 metres, which would create a plenum to carry utility pipelines and cables. Many pictures show the delaminated false ceiling panels still dangling precariously at approximately this height.

Figures 20, 21. The first picture of the interior of the building, shows thermally insulated refrigeration piping and rescue workers are cutting away something. Guy wire stays suggest this may not be a normally accessible section or work area. In the second picture rescue workers are somewhere close to the high ridge, which, judging from their height, appears to be around 13-15 metres. Note the delaminated false (drop) ceiling sandwich panels still hanging at approximately 6 metres height.

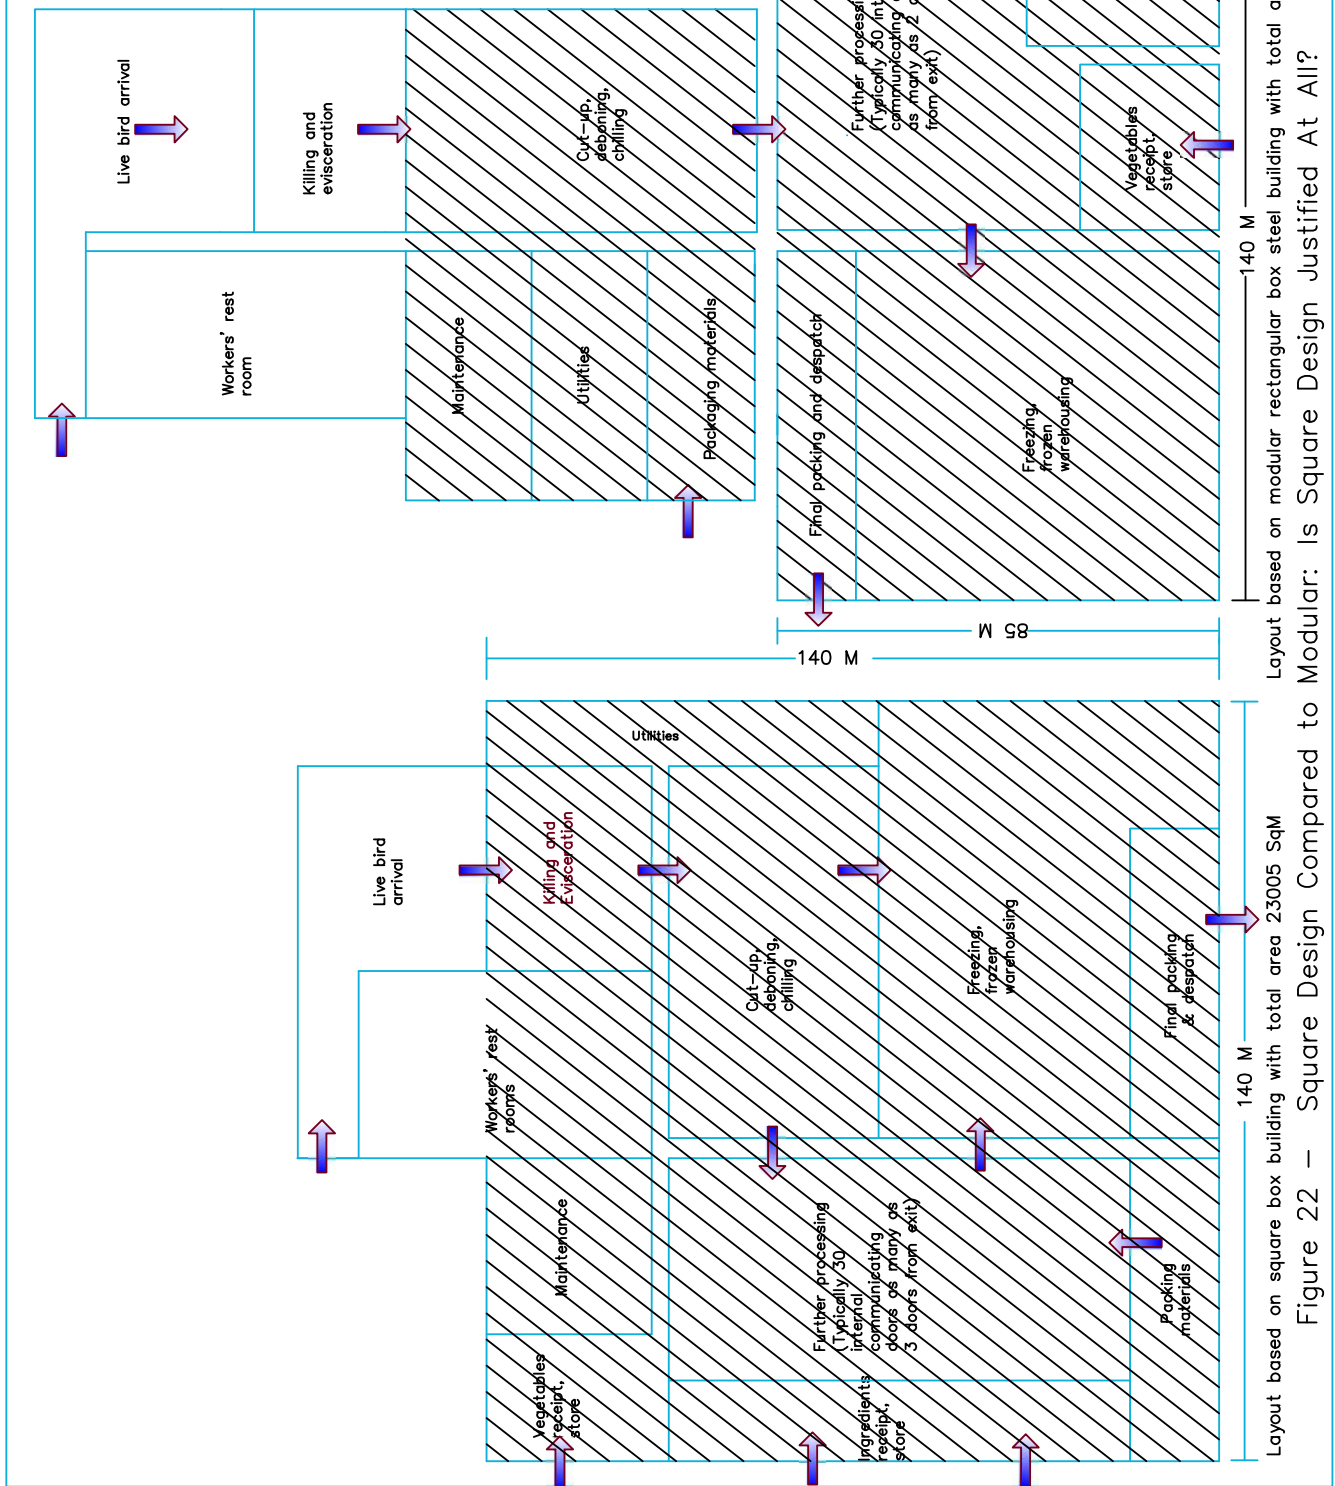
Figure 22 – Square Design Compared to Modular: Is Square Design Justified At All?

The Jiin Baoyuanfeng main shed likely has a plinth area of 17000 sqm. Assuming it was processing & portioning 12000 BPH, and had workers' rest rooms within this shed, the required floor area = +/- 16000 SqM.

Layout based on modular rectangular box steel building with total area 24050 SqM

Layout based on square box building with total area 23005 SqM

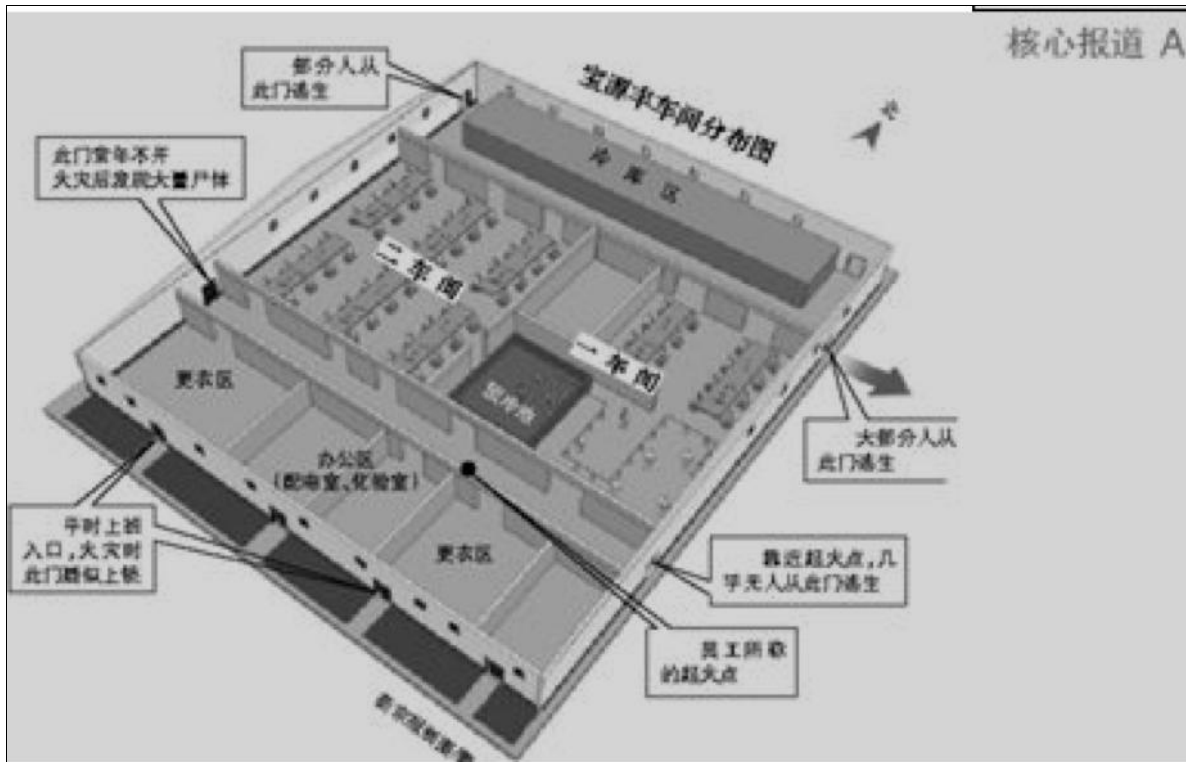
Figure 25. I came across this picture at the fag end of my writing and while this find could not be adequately used in my analysis, it did serve as a check to some of my conclusions. I cannot read the text, but my surmise about the presence of four doors to the South, the existence of live bird arrival at the East, and the presence of a warehouse on the North side and some other details are corroborated here. It is also possible that the empty rectangle just below the oblong cold store along the top edge is the central ammonia refrigeration plant – such a hypothesis would tend to support the position of dense smoke exiting the building at the commencement of the fire, as shown in Figures 3 and 4 and fit the shortest distance condition to the two cut-up halls flanking it, the cold store and the dark squarish water chill area just below it.
