Poultry Slaughterhouse Design - Materials & Safety : Lessons From Slaughterhouse Fires

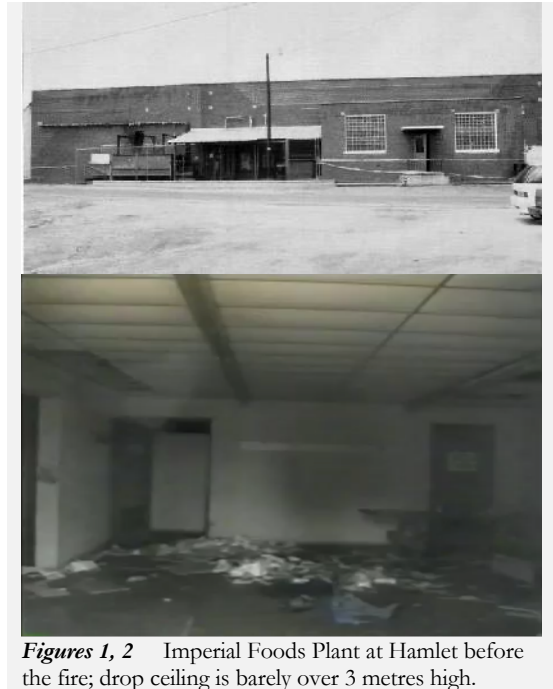
Figures 1, 2 Imperial Foods Plant at Hamlet before the fire; drop ceiling is barely over 3 metres high.

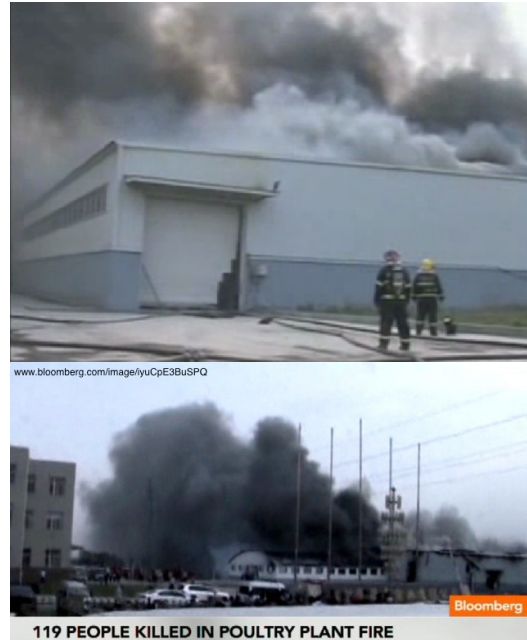
119 PEOPLE KILLED IN POULTRY PLANT FIRE
Figures 3, 4 The upper picture shows a probable packing material receipt gate (D1 of figures 7, 10). The brick wall in figure 14 is apparently behind the sheet steel-dado wall seen here. The bottom picture, taken from across the highway near the main gate area, shows the admin building on the left.

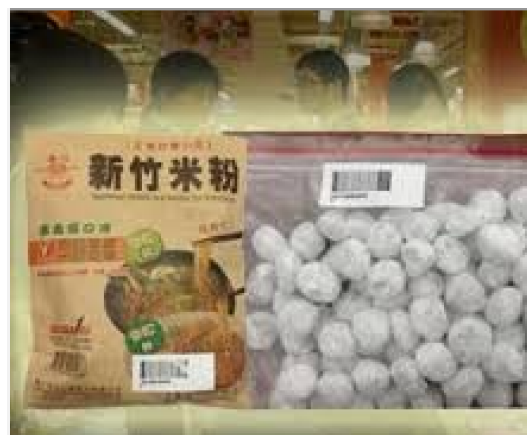
Figure 5 A pack of chicken popcorn. The picture was downloaded from the internet during the wave of news items concerning the Jilin Baoyuanfeng event. What does the Chinese text say?

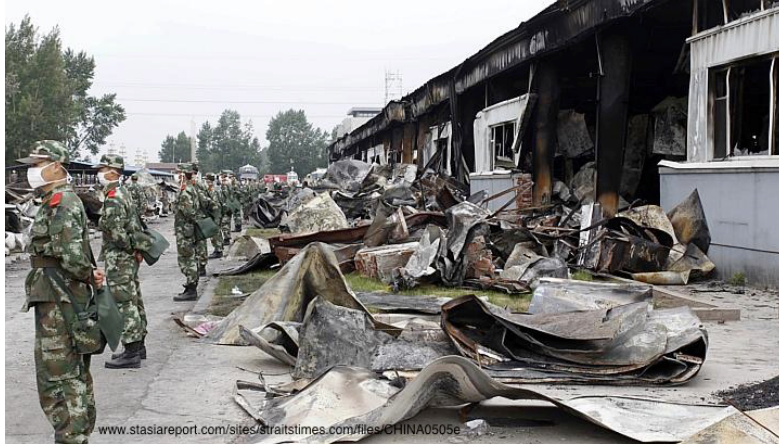
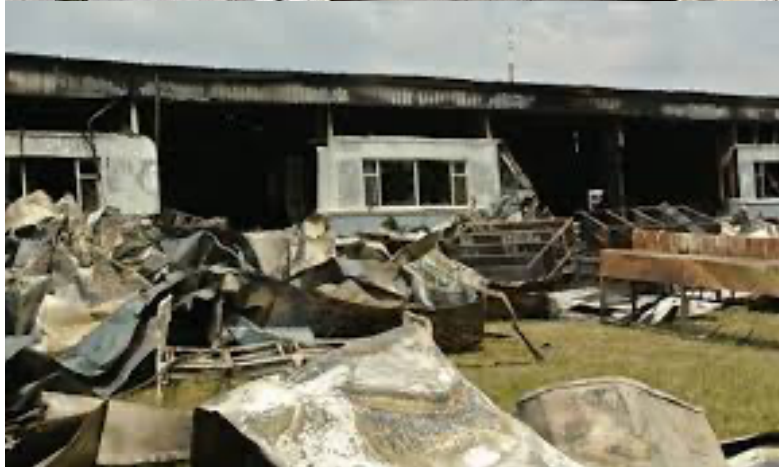
Figures 27, 28. Picture for figure 27 was taken from the north end, close to gate 2. Shed 17 has been dismantled by this time. This and figure 28 (also showing the north wall, taken from closer to where shed 17 used to be), show that sandwich panel and precast RCC panels alternated for this entire wall for the length of the despatch bay (excepting the extreme north-east end shown in figures 14). We can conclude that sandwich panel sections housed truck-loading-dock-gates (which are easier to assemble along sandwich panel walls but not along precast panels). Quite clearly except where loading dock gates were actively aligned with trucks in the process of being loaded at the time of the fire, and the drivers could have been persuaded to back off, there were no escape routes on this side. Yet some of these docks had been opened on orders of the management to rescue packed chicken (see figure 13). Partially hidden by two soldiers in the foreground in figure 27 you can see structure 03.

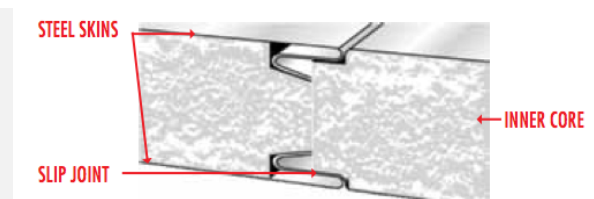
There are two types of polyurethane sandwich panels in common use for thermal insulation. These are *polyurethane* type (PUR) and an 'improved variety', touted as possessing fire-retardant properties in foamed *polyisocyanurate* (PIR). **Both types burn** – the fire-retarding variety in turn produces vast quantities of dense black smoke (see figure 43) which causes asphyxiation and obscures exit signs in workplaces and corridors. Besides carbon particles, smoke from PIR and PUR fires contains hydrogen cyanide and its variants, oxides of nitrogen, and carbon monoxide, all of these being toxic. Also, more importantly, when these polymers burn in limited air, they produce *methyl isocyanate* gas – the same that caused widespread deaths of over 1500 people in Bhopal in 1984.

Figure 34. Diagram showing continuity of core material. **Source:** Insulated Panel Council Australia Limited. (IPCA), which commenced development of a voluntary code in 2008 to deliver a better performing panel and increase fire-fighting confidence.

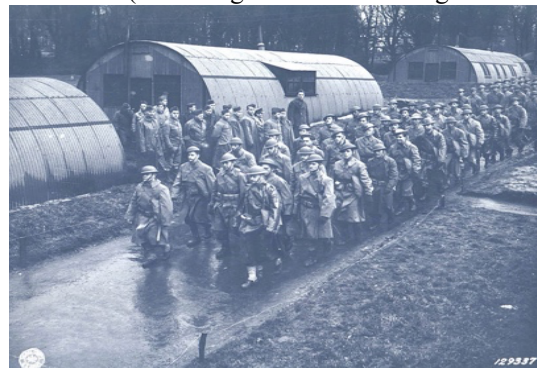
Figure 35 is a vintage picture of one such hut. *Notice the semi-circular top and absence of side walls, necessitating the construction of dormer windows for ventilation.* It is our belief that this kind of short-cut construction philosophy has influenced the design of several huts at JBPPP. Note for instance, the light steel reinforcements of the roof in the product dispatch hut in figure 23 where it has been burnt off, and the absence of doors (figure 8) except at the gable end.

Figure 35 Vintage picture of a Quonset hut³⁵ from the second World War. Note the self-supporting roof and door at the gable end. These huts were not designed for industry and afford very little ventilation possibility.
