What Happened at Jilin Baoyuanfeng on June 3, 2013

This report is in two parts – the first addressed to design professionals; the second to the public at large
Report dated July 25, 2013, Rev 1 dated August 10, 2013

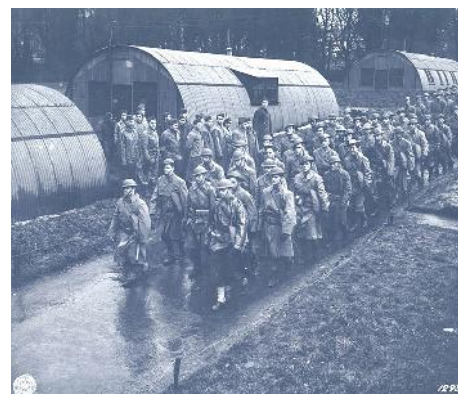
Figure 16: A Quonset hut from the Second World War. Note the self supporting roof and door at the gable end

Figure 16 is a vintage picture of one such hut. Notice the semicircular top and absence of side walls, necessitating the construction of a dormer window for ventilation. It is my belief that this construction philosophy has influenced the design of several huts adjoining the main process shed at JBPPP. Note for instance, the light steel reinforcements of the roof in the product dispatch hut where it has been burnt off and the absence of doors (Figure 5) except at the gable end.

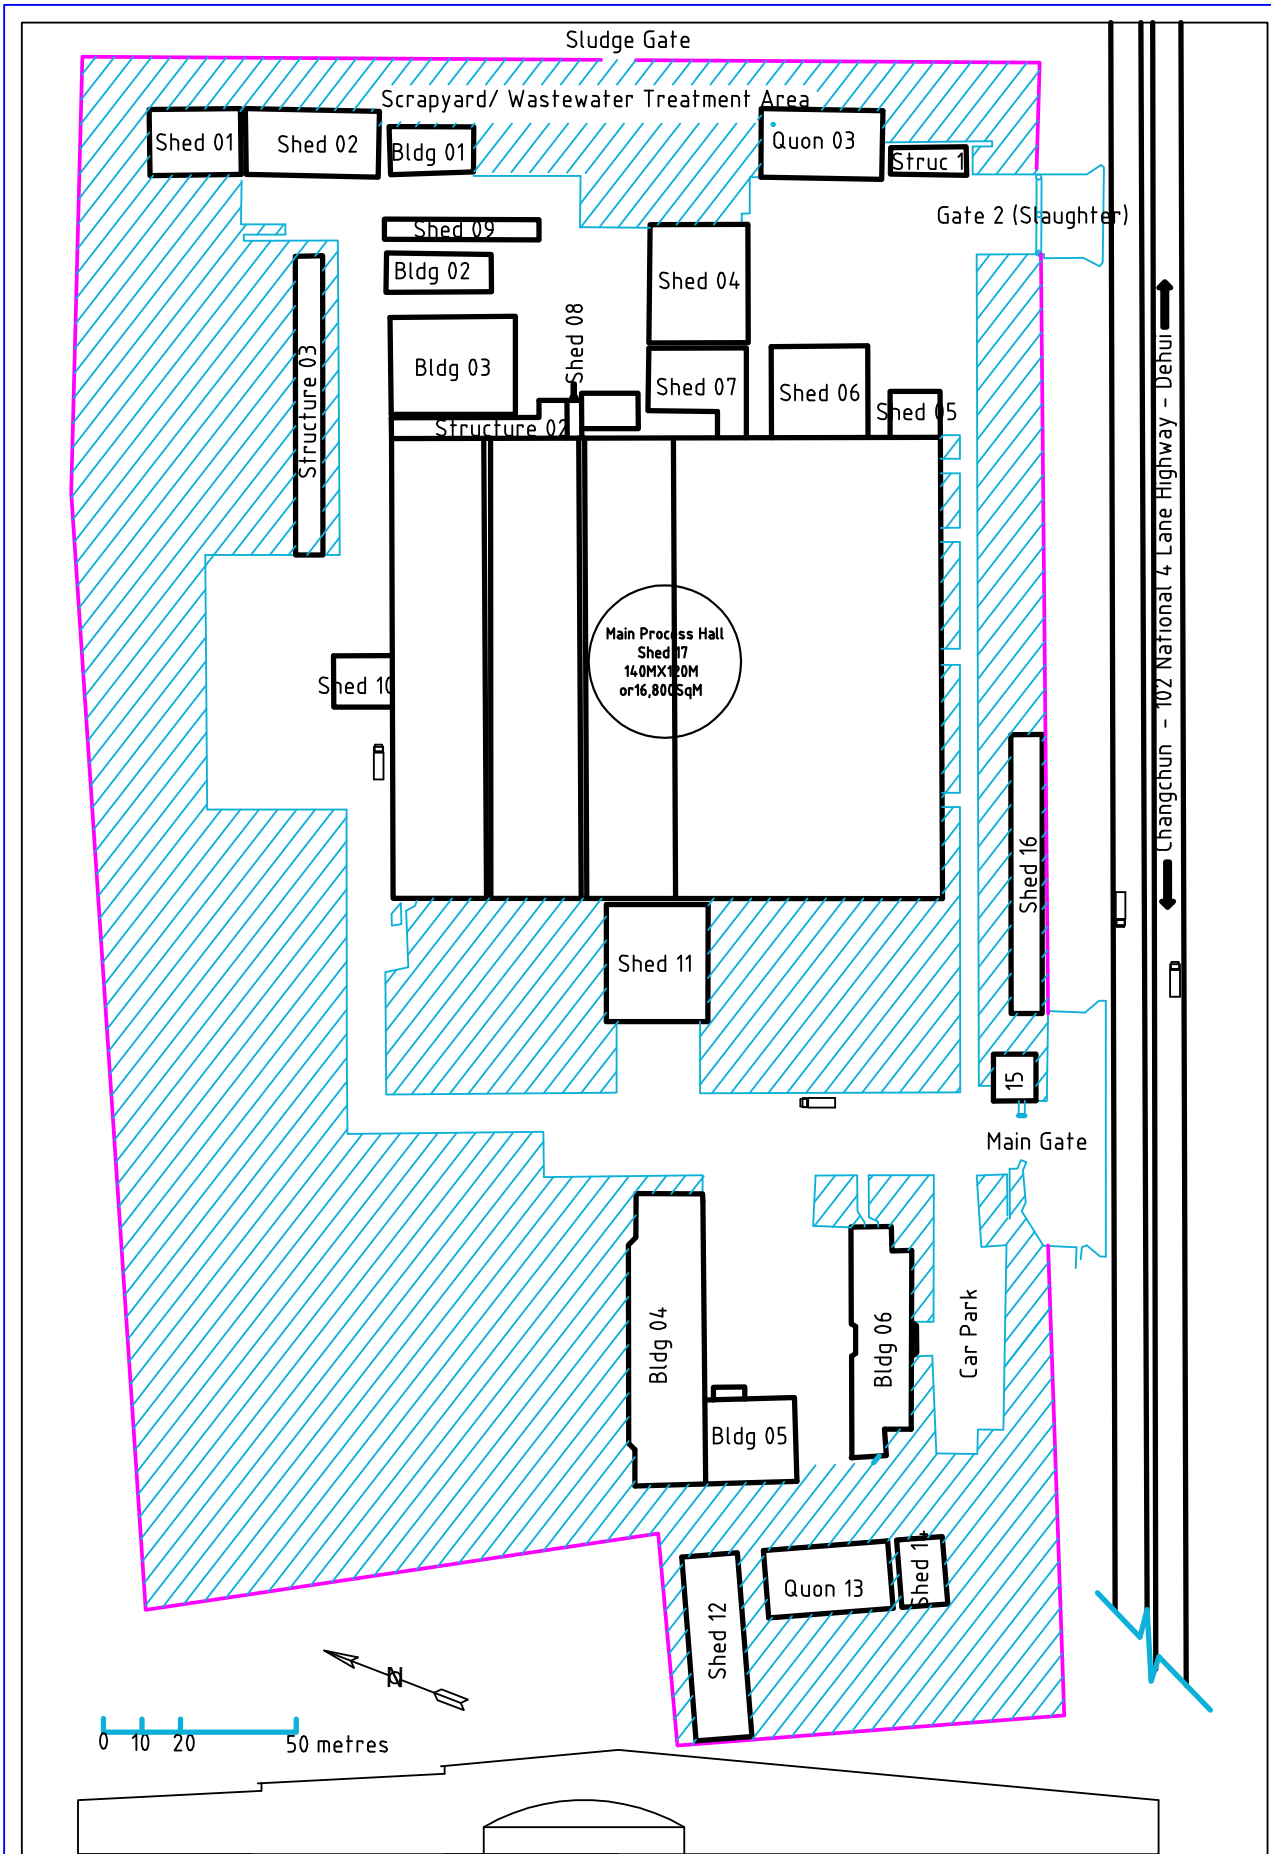
Figure 23 - Jilin Baoyuanfeng Poultry Processing Plant, imported into Autocad and traced from 100 M scale Google Map

Such a drawing may still be as much as 10-15% in error on actual dimensions, however, it does permit review of the circumstances leading to the incident and evaluation of my analysis by other design professionals. Such a drawing has been made by me. It appears as Figure 23. It shows the entire 10 hectare factory plot. I would welcome alternative interpretations and views from readers of this article.

The East end houses a mix of sheds, RCC buildings and some structures which defy analysis. The biggest shed appears to be the live bird unloading porch – the road passes right through it – which is how it should be. The clear existence of an effluent treatment area at the extreme East end of the plot precludes any doubt that this indeed is the live bird arrival end. There is even a gap in the East side fence for dumping effluent sludge into nearby farm land and there is evidence of such dumping in Figure 24.

This being the case, the East end would normally not contain any delivery gates, nor purpose-constructed workers' exits, except possibly a canteen. But a canteen for so many workers would almost certainly be a multi-storey structure connected to the main process area with a covered passageway which could also be useful as an escape destinations, provided the interconnecting doors were left open. The ground floor of this canteen building might serve as the central refrigeration plant. A likely candidate is the building marked Bldg 03 in Figure 23. The East end also houses the boiler – a chimney appears there in several photos, as in Figure 5.

North of the central ridge the shed has two longitudinally running sets of roof monitors, possibly provided with glazing and vents (Figures 22 and 23). That they do have vents is evident from the large amount of thick black smoke apparently issuing out of these vents in Figure 3 and 4. Going to the East of this part of the shed, you will see a long and narrow rectangular structure which appears to be a building housing a row of refrigeration compressors. This fits in with the theory that the fire apparently started in the West half of the building as indicated by the more extensive damage to that side and that this narrow structure or the ground floor of the RCC building adjacent to it housed the compressors.

Figures 23 and 24 show the position of out-buildings and structures. The buildings are of four basic designs – RCC multi-storey buildings, sloping steel sheet roof huts, unidentifiable structures and semi-circular self-supporting steel sheet roofs. Of the last named, there are two Quonset Huts (1 and 2 in Figure 23). The Quonset Hut design, of WW-2 vintage, was an improvement of the Nissen Hut first designed during WW-1. The design gets its name from

Does a square building actually make a compact design, reducing the need for outlying external work spaces? I think not - take a look at the reconstructed layout in Figure 23. Seven or more structures were added at the East end to accommodate diverse plant functions that were probably not suitable within it.
